Geological Survey Undertakes Concentrated Investigation of Montana Earthquake

THE HEBGEN LAKE EARTHQUAKE

THE MADISON CANYON LANDSLIDE¹

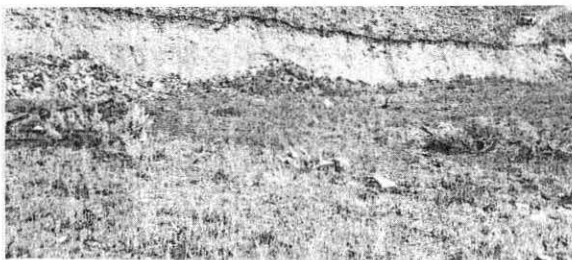
Figure 2. New scarp of Red Canyon fault where a road has been displaced. The Survey camp was in the aspen grove at upper left.

The position of the new scarps of faults that were formed are shown on the accompanying map (fig. 1). These are reactivated old faults belonging to one of the major sets of faults in the region. Views of the scarps are given in figures 2 and 3. About midnight I left my trailer to drive around the countryside and see what had happened. I discovered my access road had been broken and displaced by a fault scarp 15 feet high. The main highway also was displaced, and an automobile travelling south drove off the scarp and overturned.

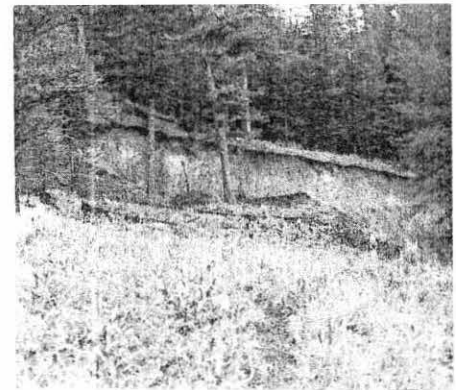
Figure 3. New scarp of the Red Canyon fault as it is typically exposed in the forested hills north of Hebgen Lake.

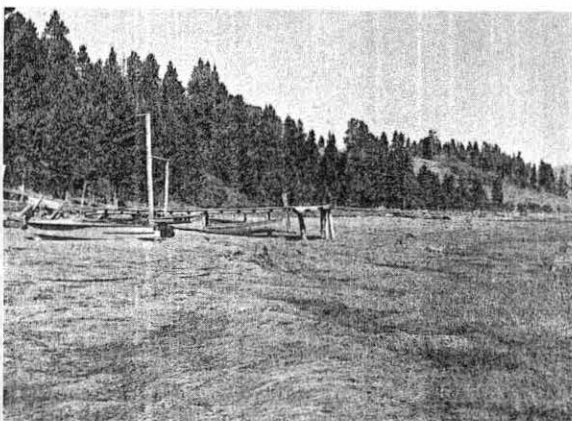
Figure 4. Emergent southwest shore of Hebgen Lake. Water weeds laid flat by the rapidly receding water.

As a result of the faulting, the floor of the valley containing Hebgen Lake has been tilted northeastward. The Madison Arm of the lake (fig. 1) has emerged whereas the northeast shore has been submerged. The exact amount of shift is not yet known partly because we await new precise leveling, but also because it is difficult as yet to tell displacement attributable to the faulting from displacement attributable to landsliding that resulted from the faulting. It appears though that the northeast shore of the lake has been submerged by about 10 feet and that the southwest shore has emerged about an equal amount. Figure 4 is a view of the emergent southwest shore of the lake; figure 5 shows the submerged northeast shore where a landslide has engulfed part of the highway.

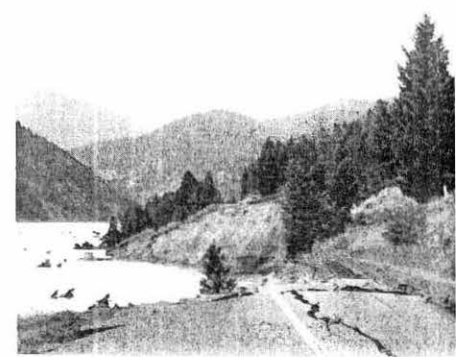
Figure 5. Submerged northeast shore of Hebgen Lake. The present shore is about 10 feet higher than the old one in this area.

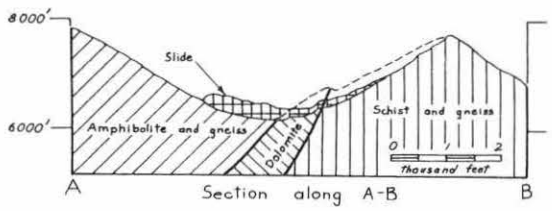
Figure 6. Geologic sketch map and cross section of the Madison Canyon landslide.

The configuration of the Madison River canyon where the slide occurred is shown in figure 6. The walls on both sides are steep, those on the south reaching 1,300 feet above the river, in part rocky but mostly thickly forested. Those of the north are higher, mainly rocky slopes with many cliffs reaching 2,000 to 3,000 feet above the river.

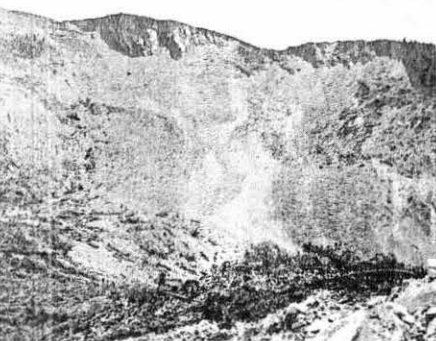
Figure 8. Scar of the Madison Canyon landslide.

The slide started at the ridge crest on the south wall 1,300 feet above the canyon floor (fig. 8). It moved north across the canyon, about 800 feet wide, rose 400 feet vertically along the north wall of the canyon and spread upstream nearly a mile from its starting point. About 90 acres of slope went down, covering an area of 135 acres with slide debris averaging 150 to 175 feet thick. A very rough calculation of the volume of debris suggests that the consolidated rock on the slope that moved was 150 feet deep in many places and perhaps 200 feet deep in the deepest part. The distribution of slide debris shows that it descended in a remarkably orderly manner; the dolomite on the lower face of the original slope forming the forward edge of the mass, was followed by the lime-silicate gneiss and finally the schist. Much of the dolomite and lime-silicate gneiss is in blocks 5 feet and larger; the schist and gneiss formed finer debris, mostly less than 1 to 3 feet in size. Material from the shear zone formed a fine-textured rock-flow which produced a flow pattern on the tail of the main slide mass.
