United States  
Department of  
Agriculture  
Forest Service  
Engineering Staff  
EM-7310-8  
July 1999

# A History of the Architecture of the USDA Forest Service

by John R. Grosvenor, Architect  
Pacific Southwest Region

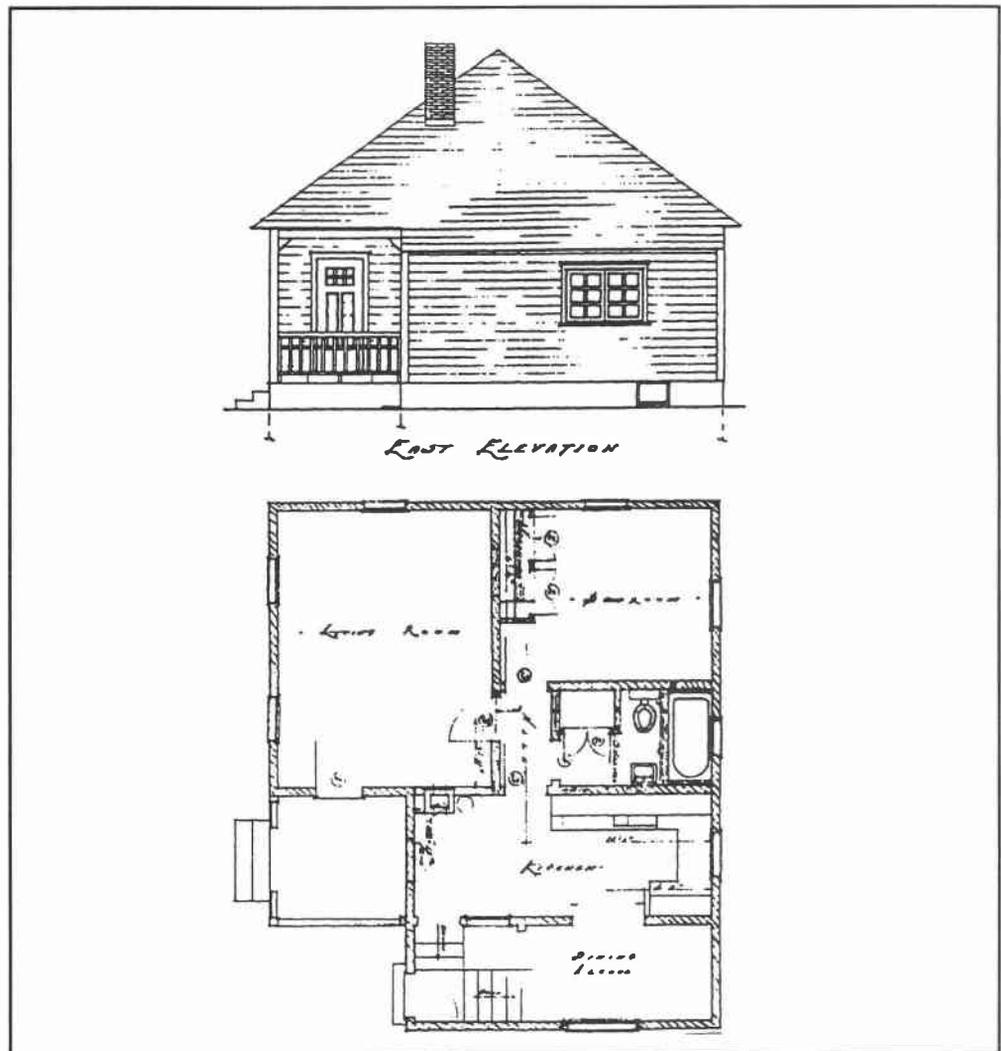
**Figure 1-11.** Plans for ranger dwelling, Glade Ranger Station, Region 2

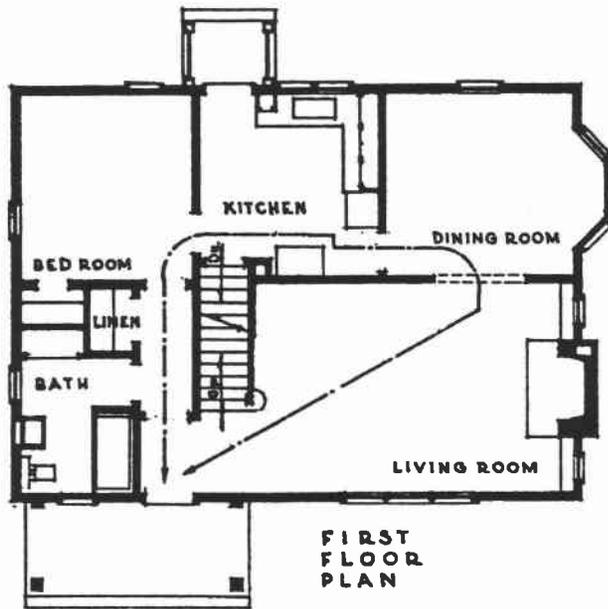
**Figure 1-18.** Groben provided guidance to help architects avoid using rooms as passageways

**INCORRECT PLANNING**  
INDIRECT CIRCULATION & LACK OF PRIVACY

He then lists 11 faults common to his observations of past planning. These include dark interior spaces, dangerous stairways, failure to provide a vestibule where weather extremes occur, rooms used as passageways (figure 1-18), rooms having insufficient usable wall space, bedrooms where a bed must be located in a corner next to a wall and moved to make it, linen closets in bathrooms, insufficient closet space, and excessive central hallways, which are uneconomical.

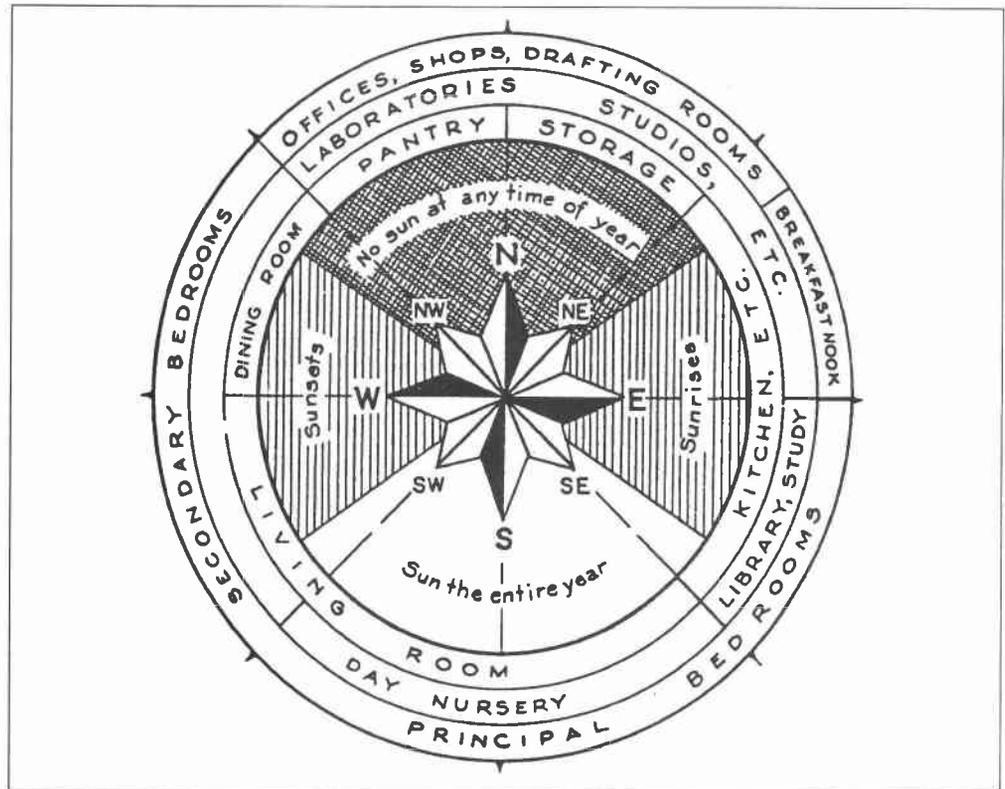
**Figure 1-19.** Groben's diagram on building orientation

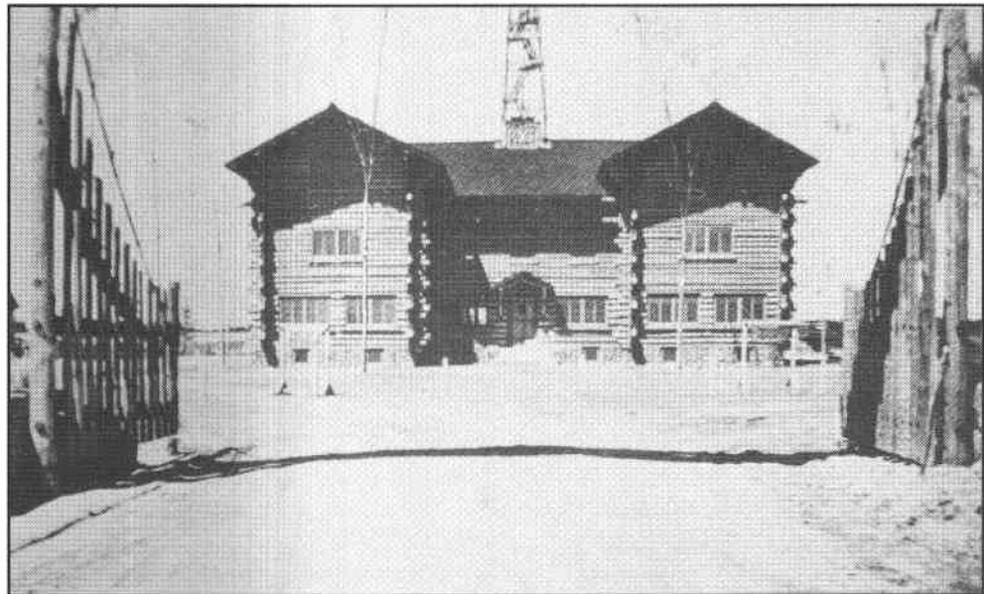
**Figure 1-31.** Headquarters Building, Chippewa National Forest, Region 9

Among the notable structural achievements in Region 9 was the building of the Chippewa National Forest Headquarters in 1935 (figure 1-31). CCC and WPA craftsmen constructed a Finnish-style notch-and-groove log building. This is considered the largest log building of its kind; it was made of native

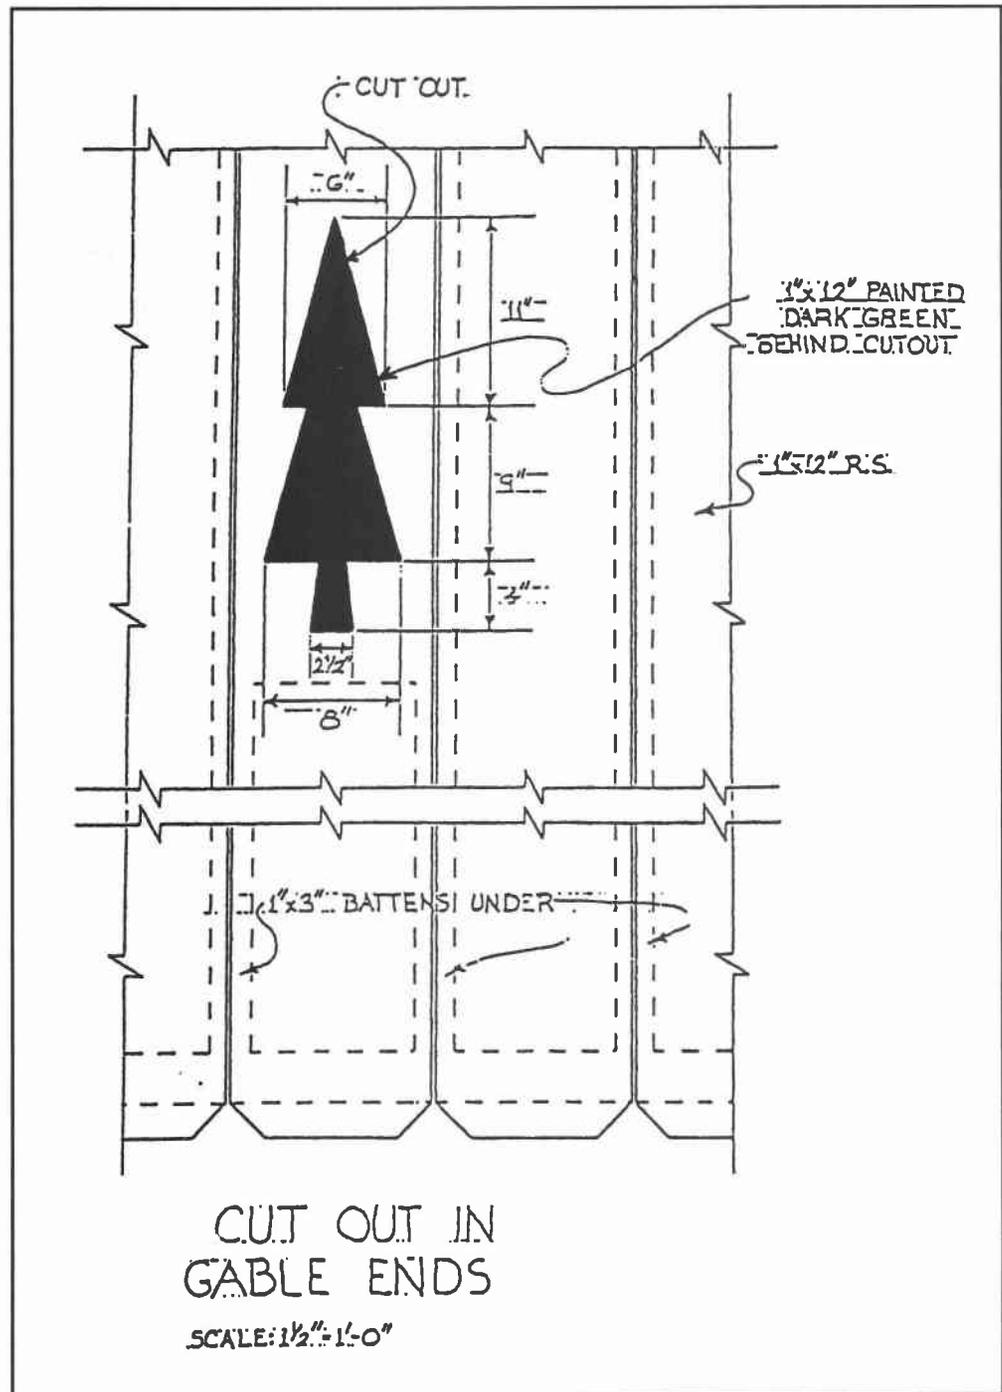
**Figure 1-33.** The distinctive pine tree logo was a common element in most of the buildings constructed by the Civilian Conservation Corps

A common element in most of the buildings constructed by the CCC is the "pine tree" logo of the Forest Service and the Civilian Conservation Corps. Nationwide, the pine tree is found in many shapes, sizes, and forms on the buildings of that period. A good example is on the Gallop Ranger Station on the Mt. Baker-Snoqualmie National Forest in Region 6 (figure 1-32). Because the pine tree symbol appears on structures in all Regions of the Forest Service, it seems certain that a directive suggesting its inclusion in design was issued from the Washington Office. The phenomenon is too widespread to be a regional innovation, and it is limited to Forest Service structures. Pine trees were cut from single boards or formed by silhouettes joined by two boards; sometimes they were cut from one board and applied to another (figure 1-33).

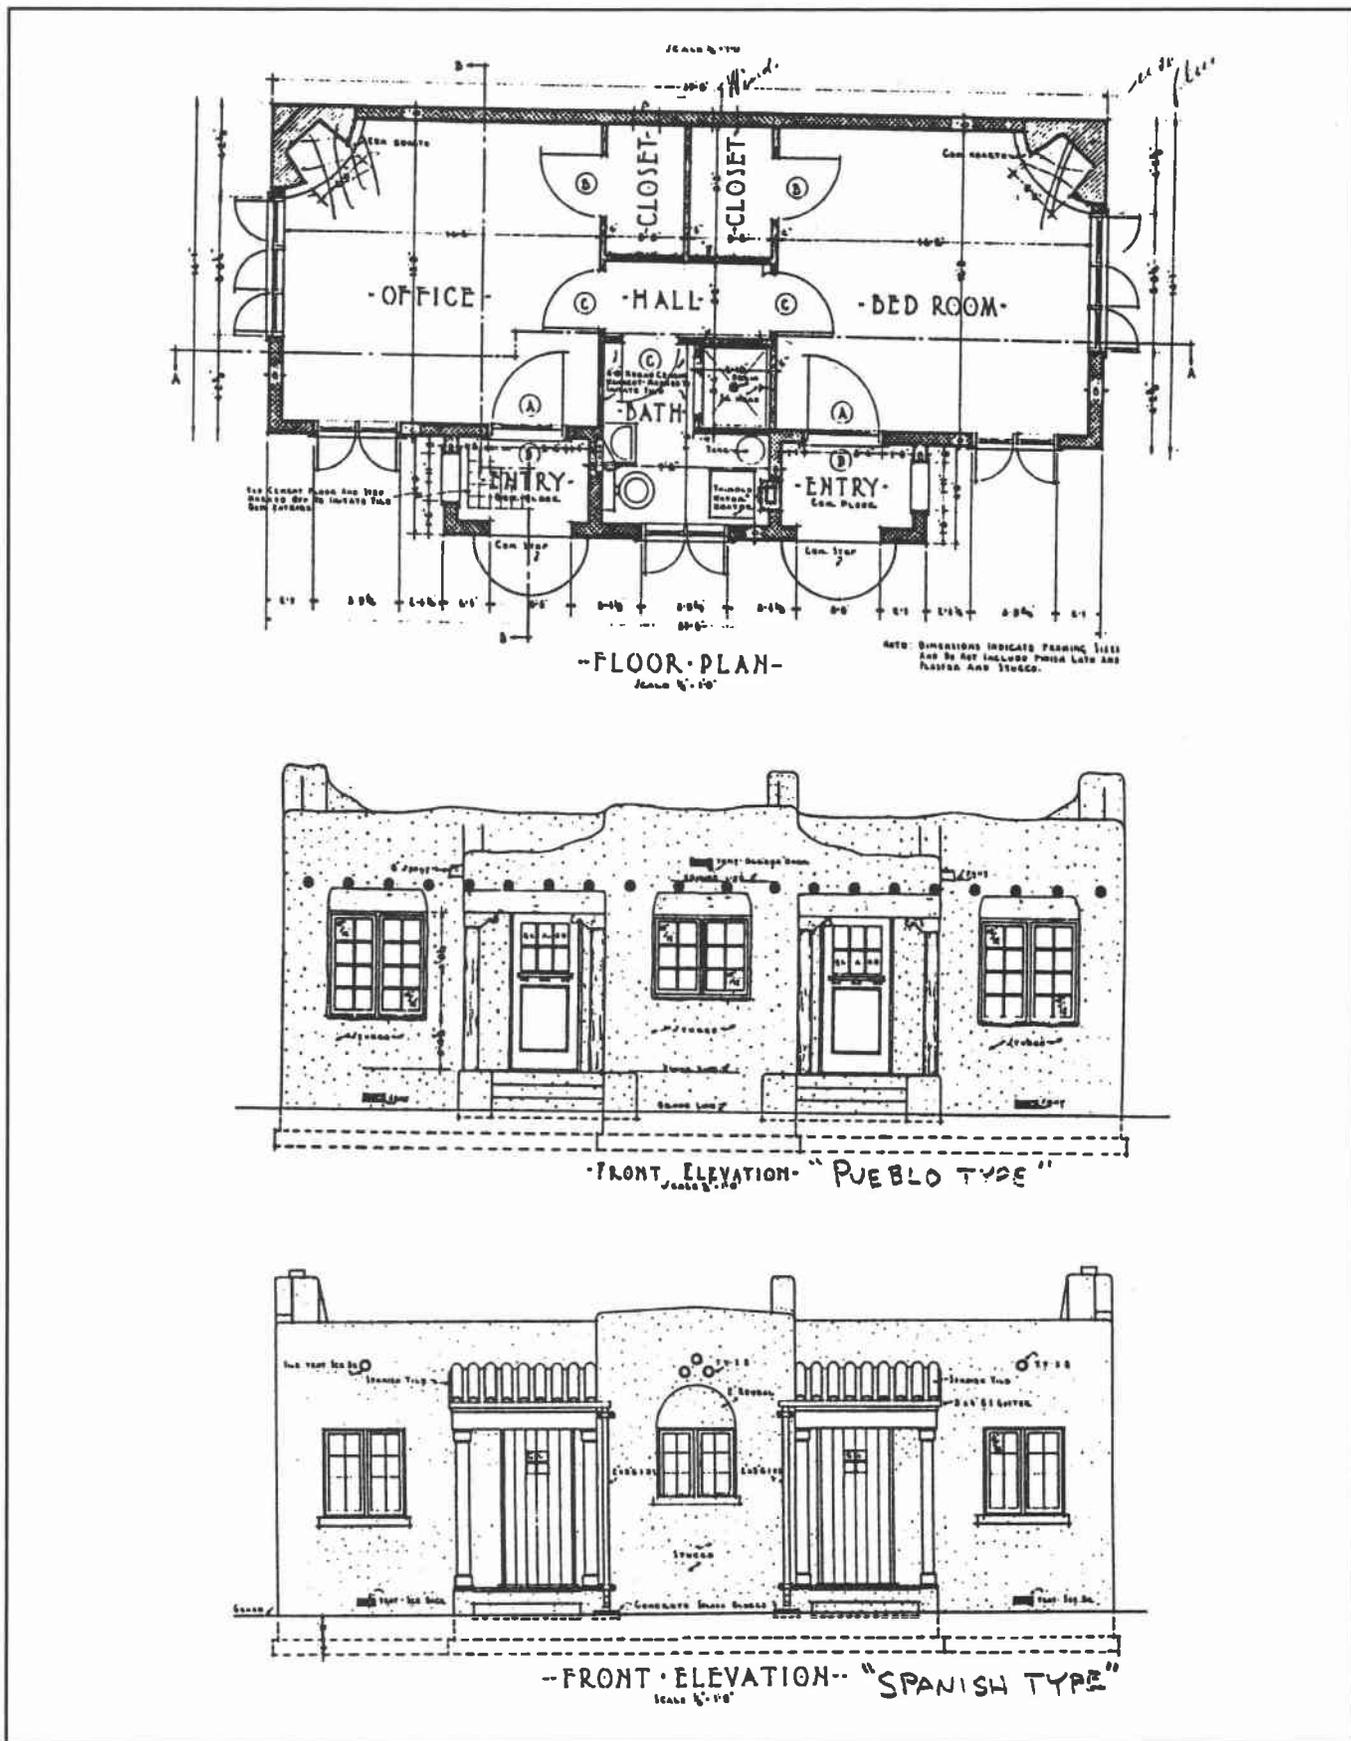
**Figure 1-39.** Standard ranger office and quarters, Region 3, designed in the Spanish style

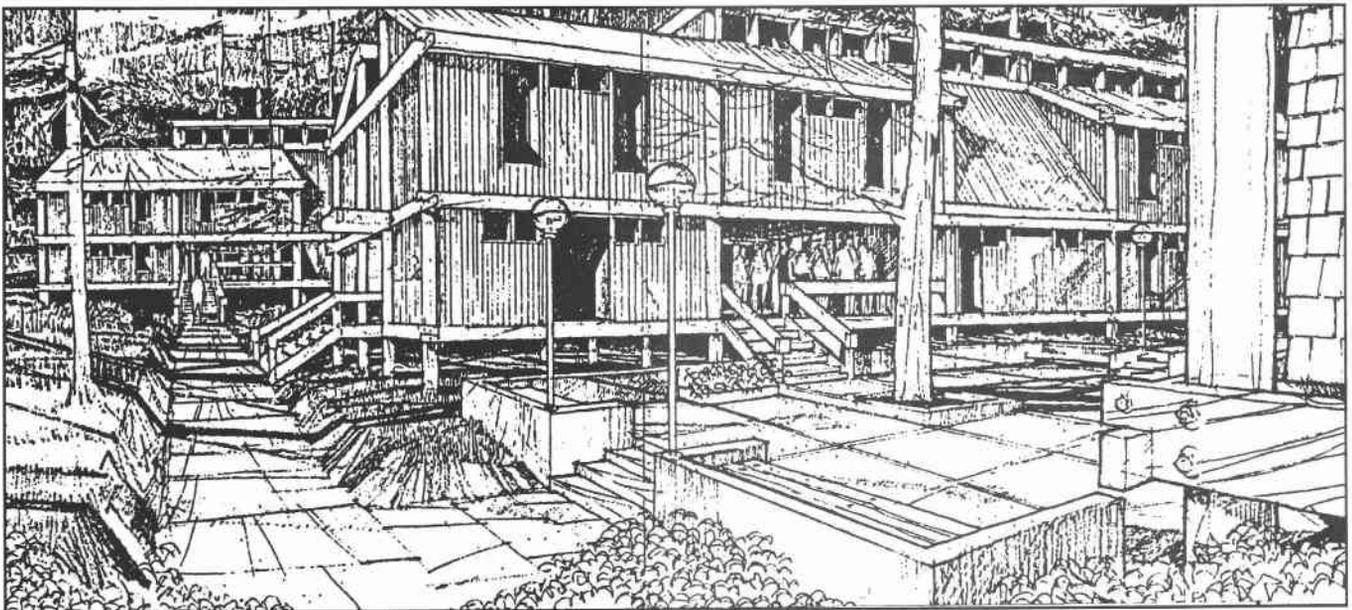
**Figure 2-9.** *Concept for Job Corps dormitories*

given the task of designing replacement buildings for these damaged trailers. A concept of pole buildings was developed for housing and dining facilities (figures 2-9 and 2-10). The architects in California were given Certificates of Merit by Chief Ed Cliff for their work (see figure 3-15 on page 216).

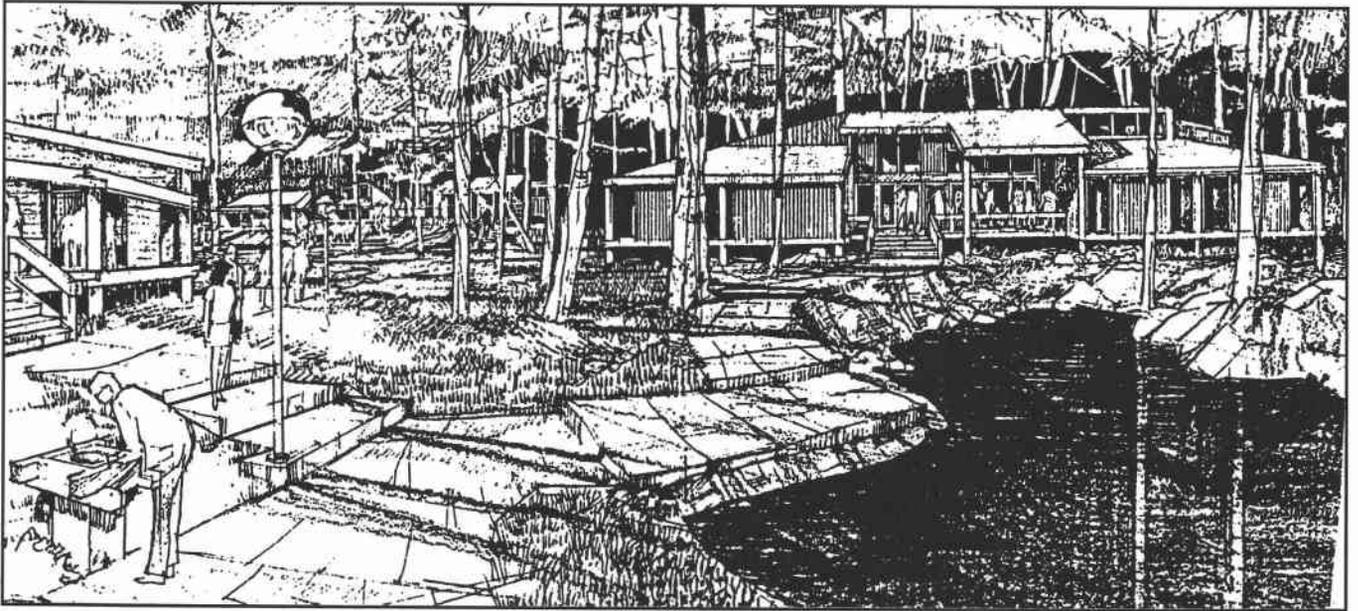
**Figure 2-10.** *Concept for Job Corps kitchen and messhall*

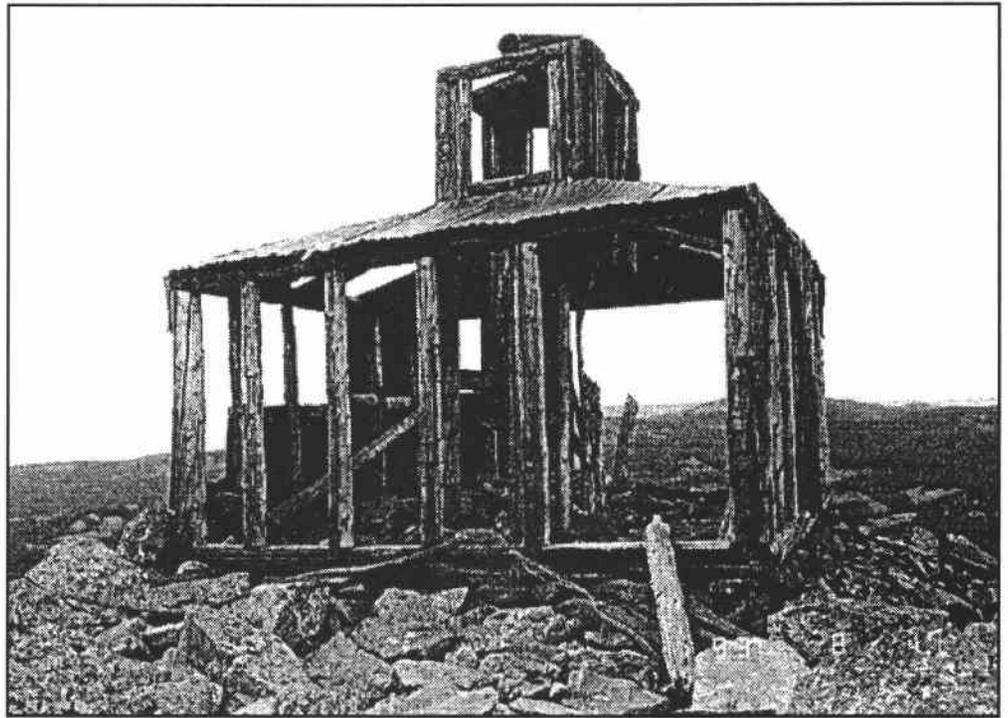
**Figure 2-66.** Leon Peak Lookout (photo taken August 1993)

The Leon Peak Lookout on the Grand Mesa National Forest in Region 2 (figure 2-66) is believed to have been constructed in 1911 and 1912 by Clay Withersteen with the help of Rosco Bloss, a local seasonal Forest Service

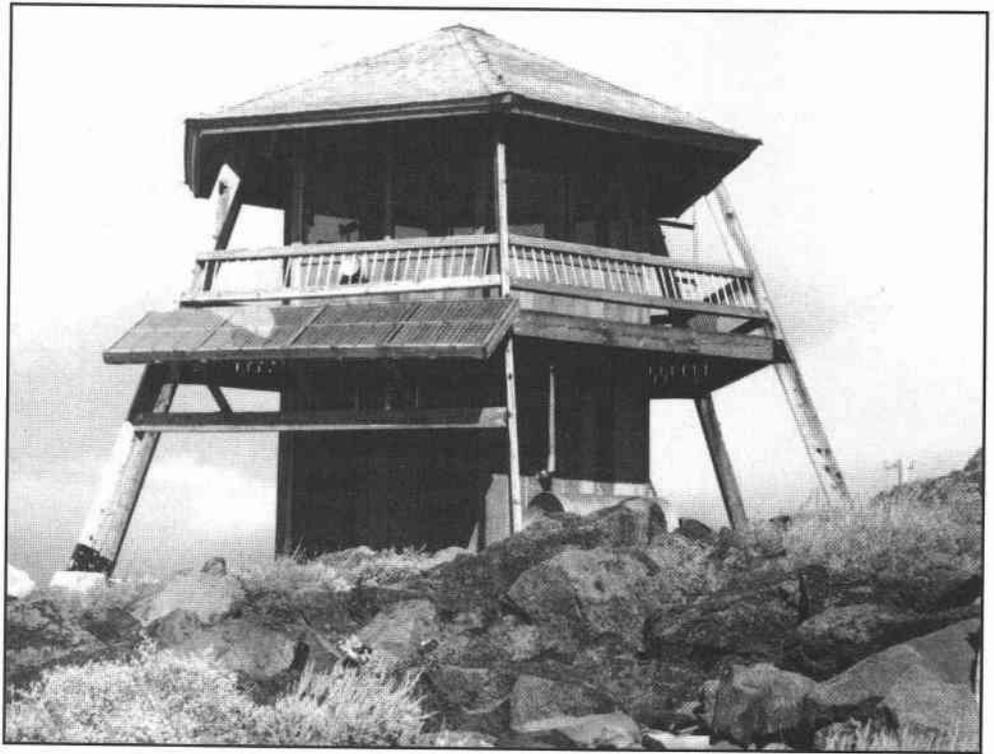
**Figure 2-68.** *Antelope Peak Lookout, Plumas National Forest (1974). This was the last lookout designed in Region 5, a wood tower and cab built in cooperation with NASA to test solar electric panels. Bob Sandusky was the designer.*

“A neat twist to kerosene lamps.” That is how one forest ranger described the new solar system that provides light and power for the Antelope Peak lookout tower in the Lassen National Forest. The nation’s first to be powered by solar cells has a panoramic view from the top of timberland and meadows, Mount Shasta, Mount Lassen and cool blue Eagle Lake. Atop the 7,684-foot peak, the hexagonal tower sits poised like a rustic spaceship. On its south-facing side are eight panels

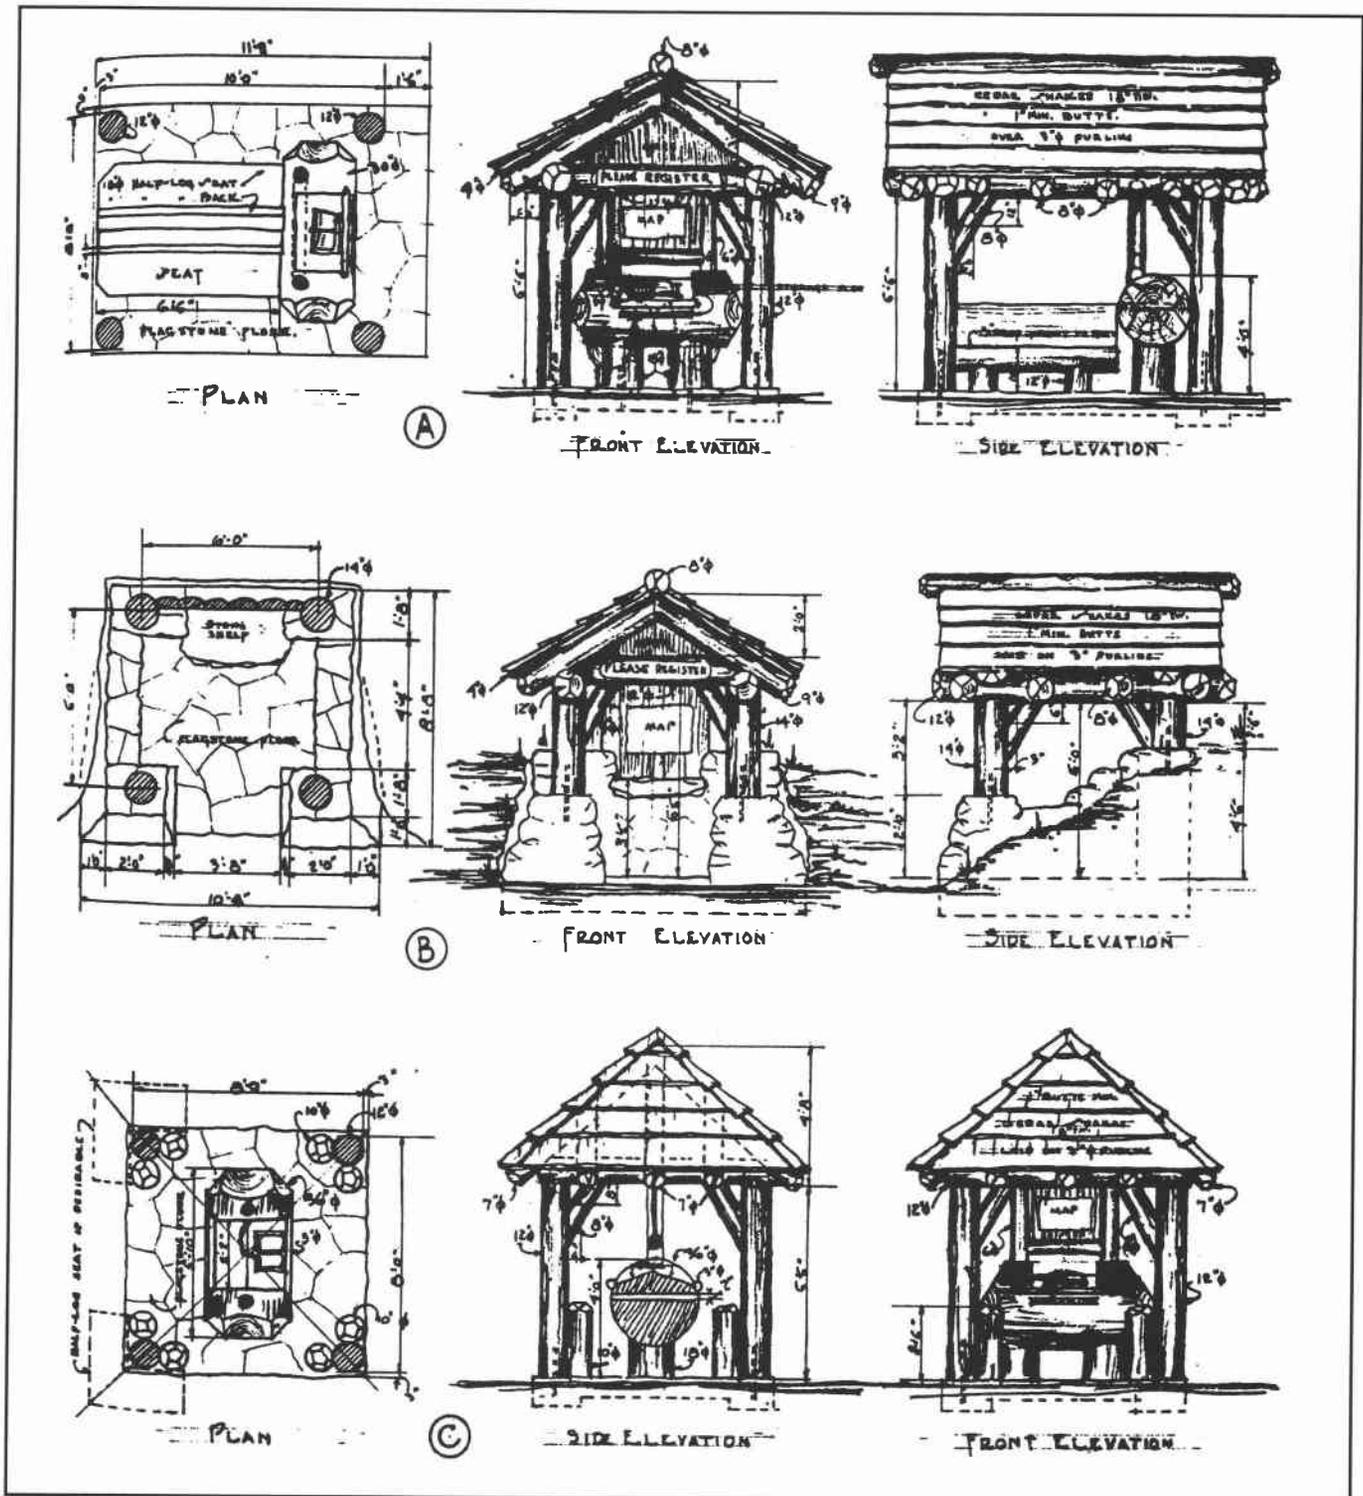
Figure 2-77. Design for a registry booth from the Region 6 Recreation Handbook (1935)

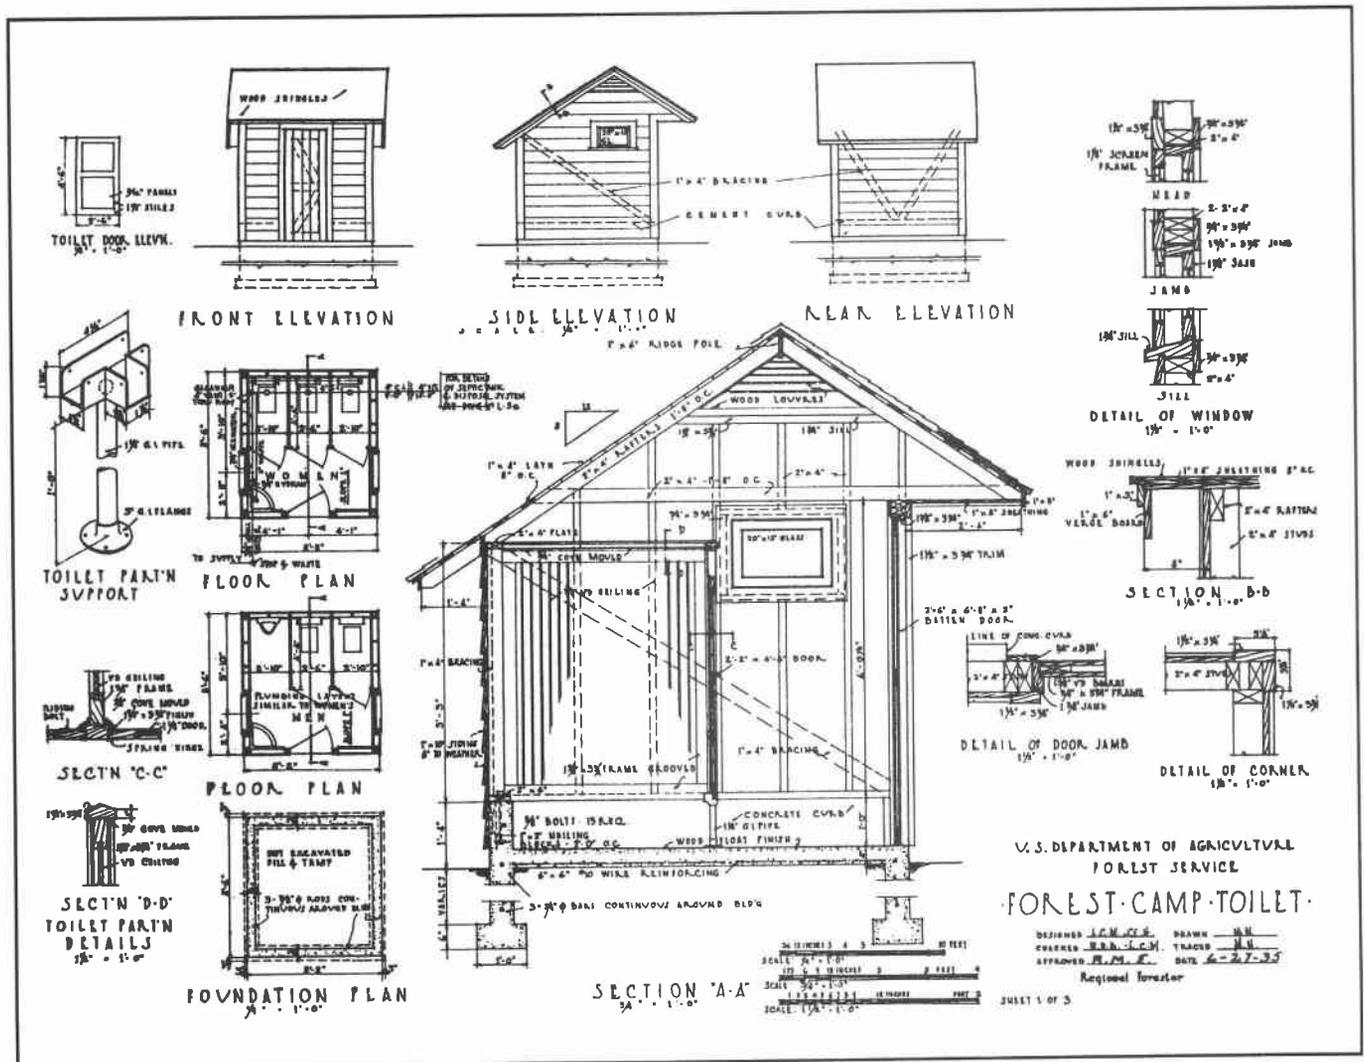
Figure 2-78. Design for a comfort station from the Eastern Region's Recreation Handbook (1933)

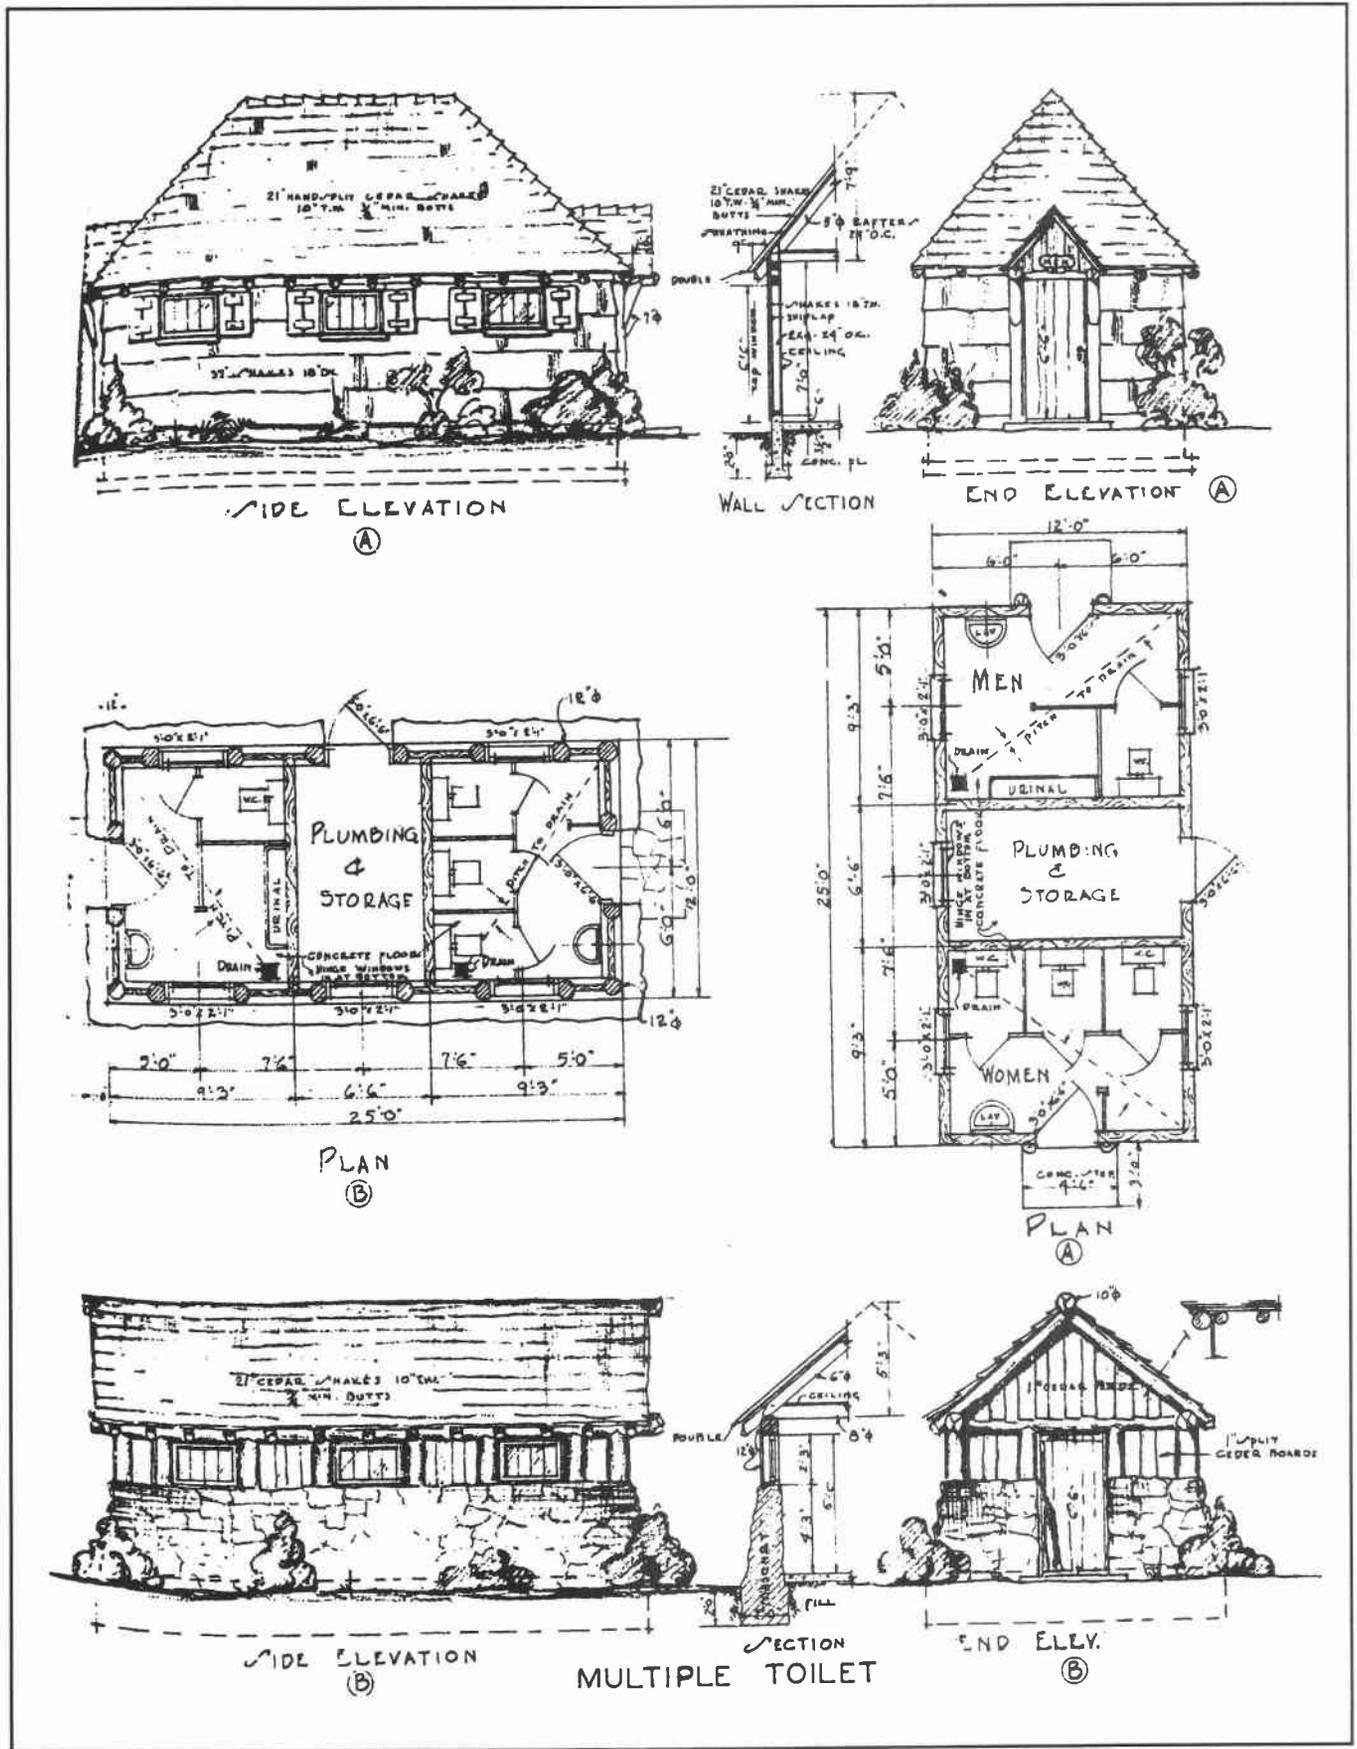
Figure 2-79. Comfort station with separate multiple toilets, Region 6 (1936)

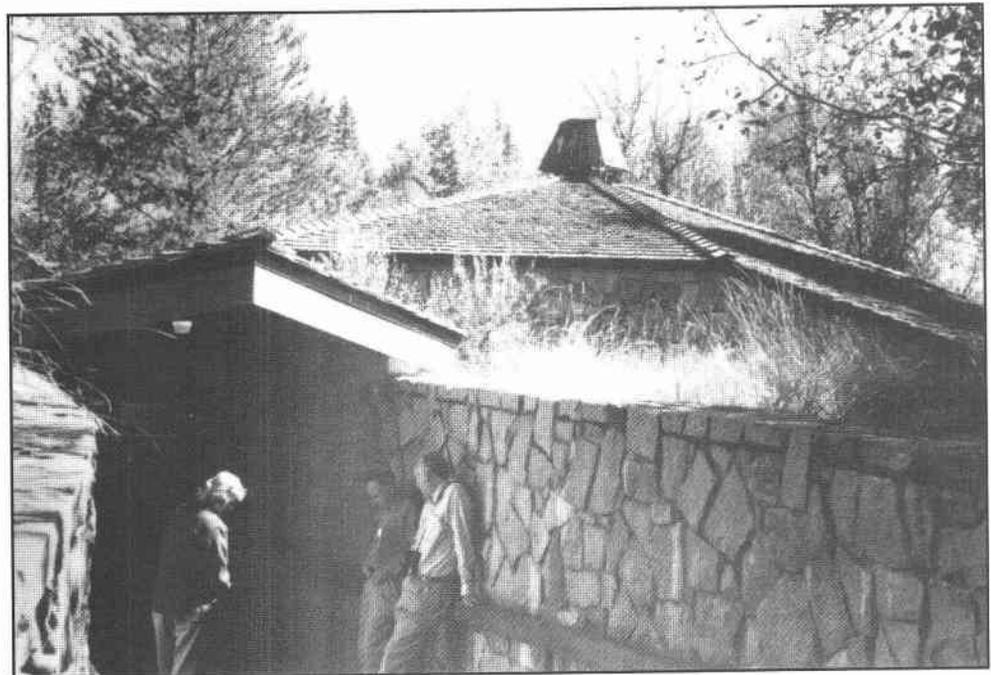
**Figure 2-110.** Stream Profile Chamber, entrance detail

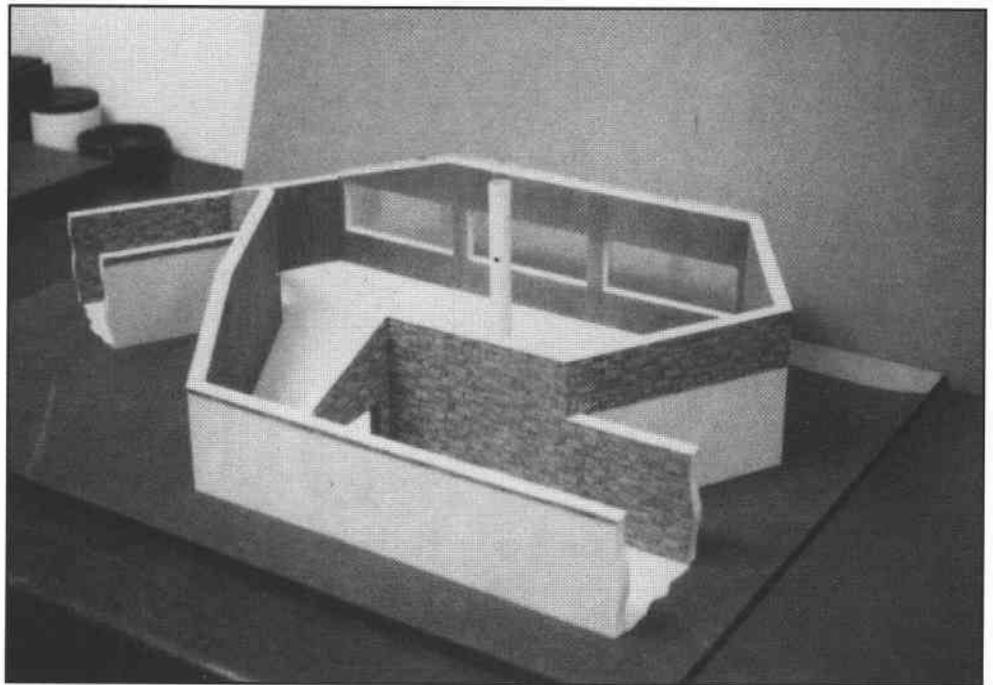
**Figure 2-111.** Scale model of Stream Profile Chamber
